**Re-inspection (Material Only) Asbestos Survey  
Of**

**Newbury Depot  
Pound Lane, Thatcham  
Newbury, Berkshire, RG19 3TQ**

**Report Ref: FTZI49422-013/001R**

**March 2017**

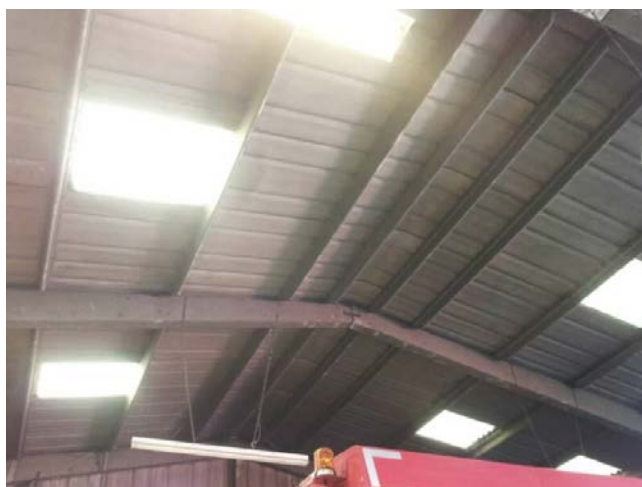
Material Assessment			
Product Type	Extent of Damage	Surface Treatment	Asbestos Type
1	1	1	1

Total Scores		
Material Risk	Priority Risk	Risk Assessment
4	-	4/D

Recommendations	Action Date
<i>Re-inspect at recommended intervals.</i>	15/03/2018

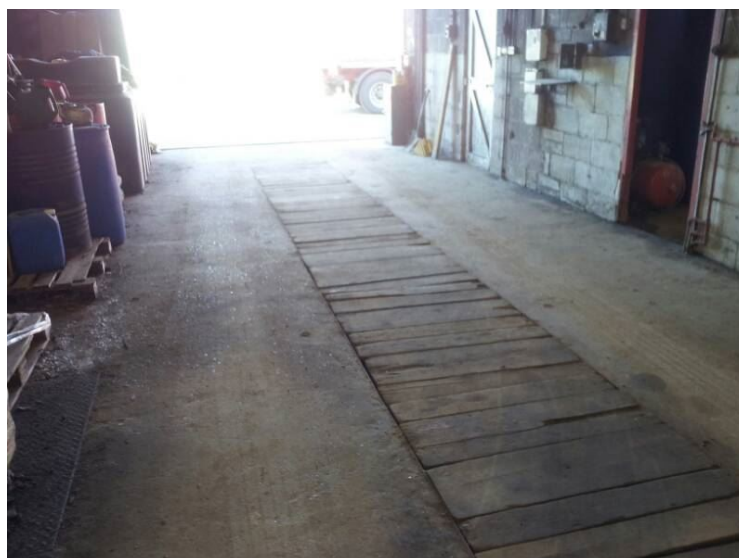
<b>Site:</b>	Newbury Depot	<b>Date of Survey:</b>	15th March 2017
<b>Building:</b>		<b>Survey Conducted By:</b>	Michael Mackenzie (Lead)
<b>Floor:</b>	Office Block & Workshop		
<b>Room Ref:</b>	0/006 Workshop		
<b>Form:</b>	-	<b>Sample No:</b>	-
<b>Extent:</b>	-	<b>Lab Analysis Result:</b>	Presumed
<b>Location:</b>	No access to inspect inspection pit.

Recommendations	Action Date
<i>Non-accessed area. This area should be regarded as containing asbestos until assessed by a competent person.</i>	Before Works

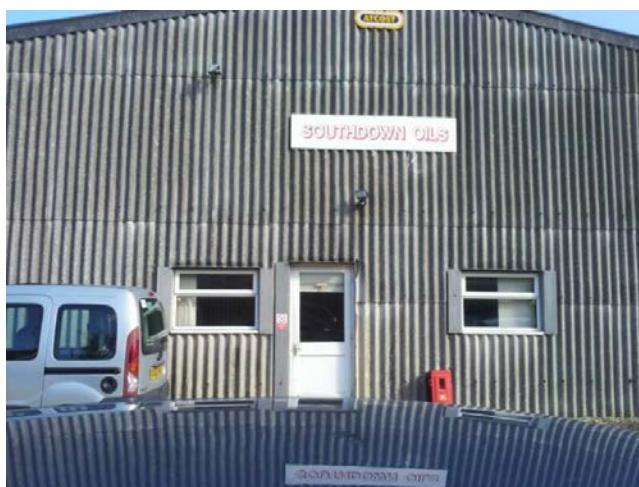
<b>Site:</b>	Newbury Depot	<b>Date of Survey:</b>	15th March 2017
<b>Building:</b>		<b>Survey Conducted By:</b>	Michael Mackenzie (Lead)
<b>Floor:</b>	Office Block & Workshop		
<b>Room Ref:</b>	Exterior		
<b>Form:</b>	Cement Products	<b>Sample No:</b>	Visual
<b>Extent:</b>	300 sqm	<b>Lab Analysis Result:</b>	Chrysotile
<b>Location:</b>	Corrugated cement sheets forming front wall, facias and barge boards

Material Assessment			
Product Type	Extent of Damage	Surface Treatment	Asbestos Type
1	1	1	1

Total Scores		
Material Risk	Priority Risk	Risk Assessment
4	-	4/D

Recommendations	Action Date
<i>Re-inspect at recommended intervals.</i>	15/03/2018

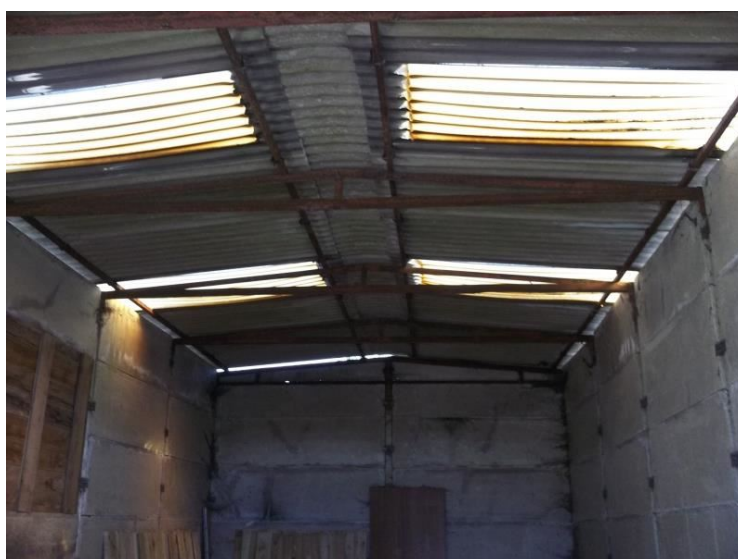
<b>Site:</b>	Newbury Depot	<b>Date of Survey:</b>	15th March 2017
<b>Building:</b>		<b>Survey Conducted By:</b>	Michael Mackenzie (Lead)
<b>Floor:</b>	Garage/Store		
<b>Room Ref:</b>	0/001 Garage/Store	<b>Sample No:</b>	S276778
<b>Form:</b>	Cement Products	<b>Lab Analysis Result:</b>	Chrysotile
<b>Extent:</b>	8 sqm		
<b>Location:</b>	Corrugated cement roofing

Material Assessment			
Product Type	Extent of Damage	Surface Treatment	Asbestos Type
1	1	1	1

Total Scores		
Material Risk	Priority Risk	Risk Assessment
4	-	4/D

Recommendations	Action Date
<i>Re-inspect at recommended intervals.</i>	15/03/2018

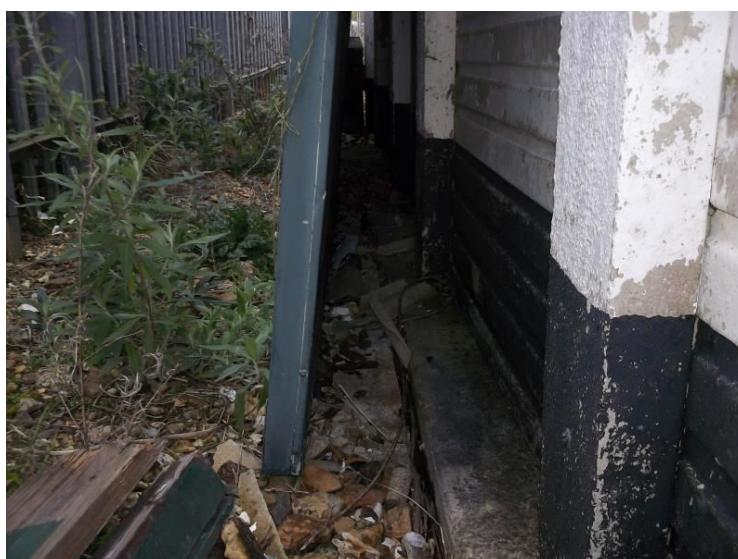
<b>Site:</b>	Newbury Depot	<b>Date of Survey:</b>	16th March 2015
<b>Building:</b>		<b>Survey Conducted By:</b>	William Doward (Lead)
<b>Floor:</b>	Garage/Store		
<b>Room Ref:</b>	Exterior		
<b>Form:</b>	Cement Products	<b>Sample No:</b>	S275393
<b>Extent:</b>	<1 sqm	<b>Lab Analysis Result:</b>	Not Detected
<b>Location:</b>	Cement debris to left side of building.

Total Scores		
Material Risk	Priority Risk	Risk Assessment
-	-	-/E

Recommendations	Action Date
<i>Not applicable</i>	-

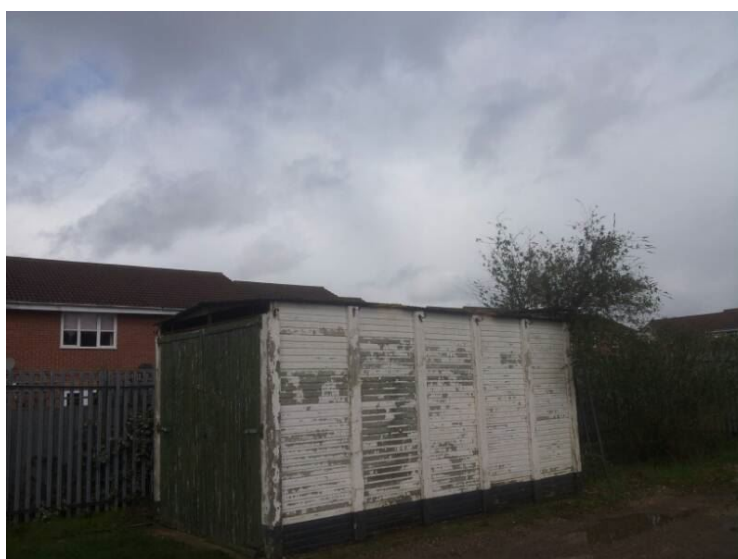
<b>Site:</b>	Newbury Depot	<b>Date of Survey:</b>	15th March 2017
<b>Building:</b>		<b>Survey Conducted By:</b>	Michael Mackenzie (Lead)
<b>Floor:</b>	Garage/Store		
<b>Room Ref:</b>	Exterior		
<b>Form:</b>	Cement Products	<b>Sample No:</b>	As S276778
<b>Extent:</b>	8 sqm	<b>Lab Analysis Result:</b>	Chrysotile
<b>Location:</b>	Corrugated cement roofing

Material Assessment			
Product Type	Extent of Damage	Surface Treatment	Asbestos Type
1	1	1	1

Total Scores		
Material Risk	Priority Risk	Risk Assessment
4	-	4/D

Recommendations	Action Date
<i>Re-inspect at recommended intervals.</i>	15/03/2018

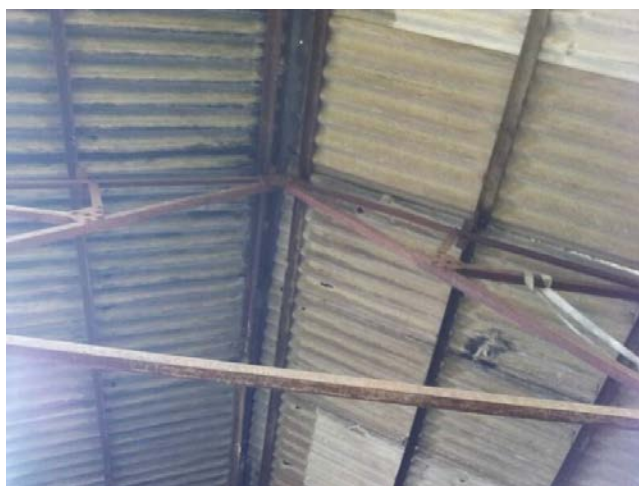
<b>Site:</b>	Newbury Depot	<b>Date of Survey:</b>	15th March 2017
<b>Building:</b>		<b>Survey Conducted By:</b>	Michael Mackenzie (Lead)
<b>Floor:</b>	Workshop and Mess Room		
<b>Room Ref:</b>	0/001 Workshop		
<b>Form:</b>	Cement Products	<b>Sample No:</b>	Visual
<b>Extent:</b>	200sqm	<b>Lab Analysis Result:</b>	Chrysotile
<b>Location:</b>	Corrugated roof sheets

Material Assessment			
Product Type	Extent of Damage	Surface Treatment	Asbestos Type
1	1	1	1

Total Scores		
Material Risk	Priority Risk	Risk Assessment
4	-	4/D

Recommendations	Action Date
<i>Re-inspect at recommended intervals.</i>	15/03/2018

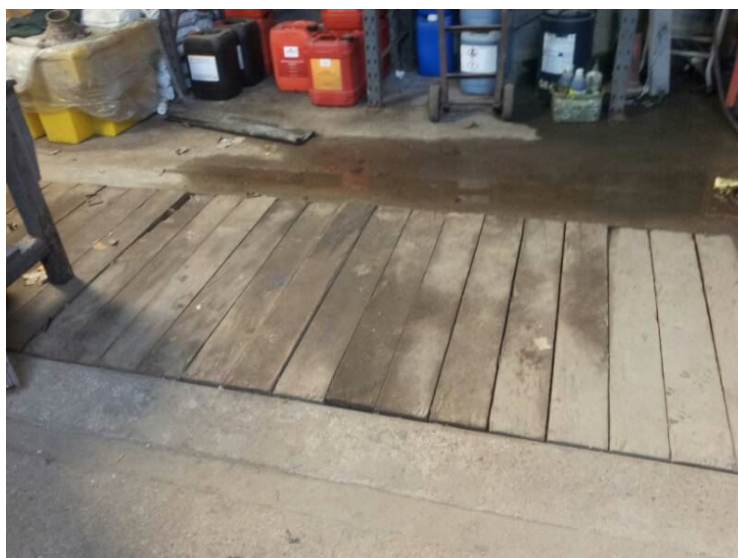
<b>Site:</b>	Newbury Depot	<b>Date of Survey:</b>	15th March 2017
<b>Building:</b>		<b>Survey Conducted By:</b>	Michael Mackenzie (Lead)
<b>Floor:</b>	Workshop and Mess Room		
<b>Room Ref:</b>	0/001 Workshop		
<b>Form:</b>	-	<b>Sample No:</b>	-
<b>Extent:</b>	-	<b>Lab Analysis Result:</b>	Presumed
<b>Location:</b>	No access to inspection pit.

Recommendations	Action Date
<i>Non-accessed area. This area should be regarded as containing asbestos until assessed by a competent person.</i>	Before Works

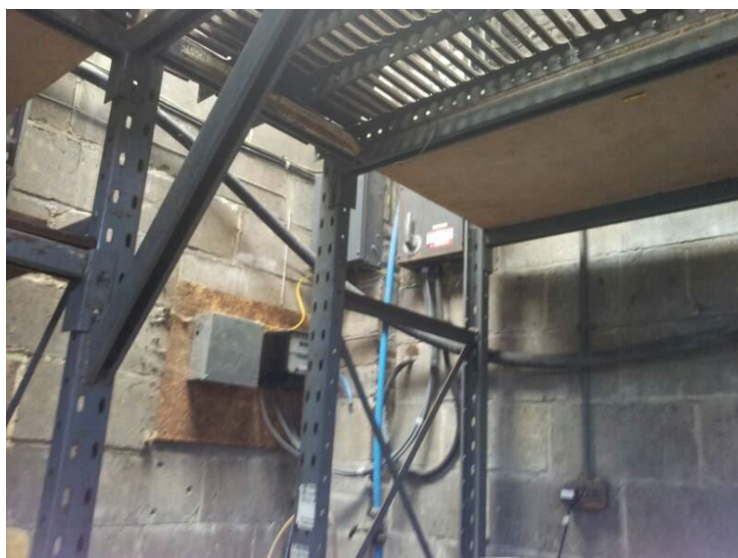
<b>Site:</b>	Newbury Depot	<b>Date of Survey:</b>	15th March 2017
<b>Building:</b>		<b>Survey Conducted By:</b>	Michael Mackenzie (Lead)
<b>Floor:</b>	Workshop and Mess Room		
<b>Room Ref:</b>	0/001 Workshop		
<b>Form:</b>	Woven Textile Products	<b>Sample No:</b>	-
<b>Extent:</b>	-	<b>Lab Analysis Result:</b>	Presumed
<b>Location:</b>	No access to live electrics

Recommendations	Action Date
<i>Non-accessed area. This area should be regarded as containing asbestos until assessed by a competent person.</i>	Before Works

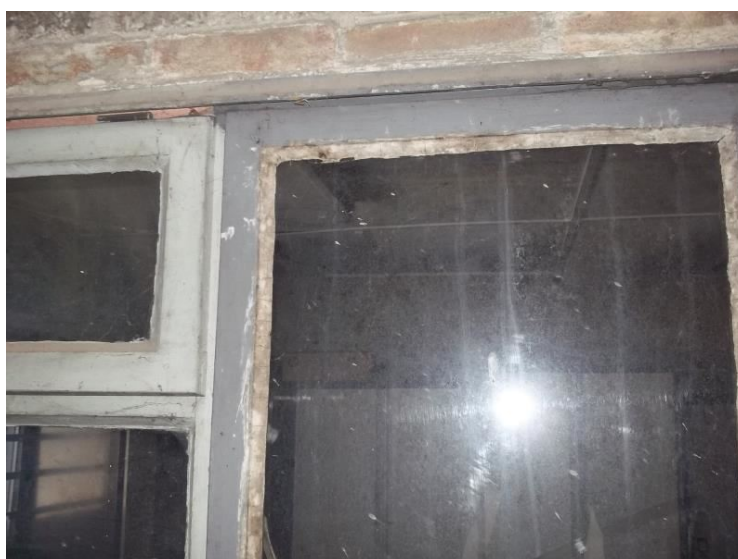
<b>Site:</b>	Newbury Depot	<b>Date of Survey:</b>	16th March 2015
<b>Building:</b>		<b>Survey Conducted By:</b>	William Doward (Lead)
<b>Floor:</b>	Workshop and Mess Room		
<b>Room Ref:</b>	0/001 Workshop		
<b>Form:</b>	Gaskets	<b>Sample No:</b>	S275397
<b>Extent:</b>	<5 lin m	<b>Lab Analysis Result:</b>	Not Detected
<b>Location:</b>	Window putty to room 0/001 on to 0/002

Total Scores		
Material Risk	Priority Risk	Risk Assessment
-	-	-/E

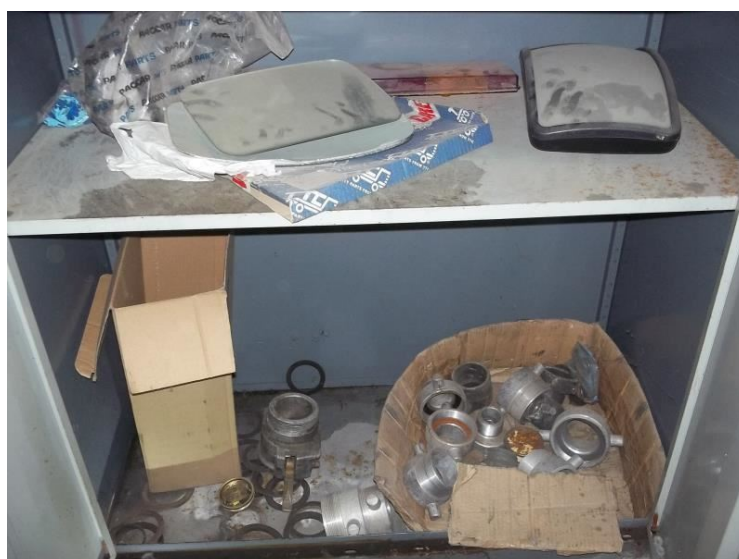
<b>Site:</b>	Newbury Depot	<b>Date of Survey:</b>	16th March 2015
<b>Building:</b>		<b>Survey Conducted By:</b>	William Doward (Lead)
<b>Floor:</b>	Workshop and Mess Room		
<b>Room Ref:</b>	0/001 Workshop		
<b>Form:</b>	Gaskets	<b>Sample No:</b>	S275400
<b>Extent:</b>	10 NO.	<b>Lab Analysis Result:</b>	Not Detected
<b>Location:</b>	Gaskets in cupboard

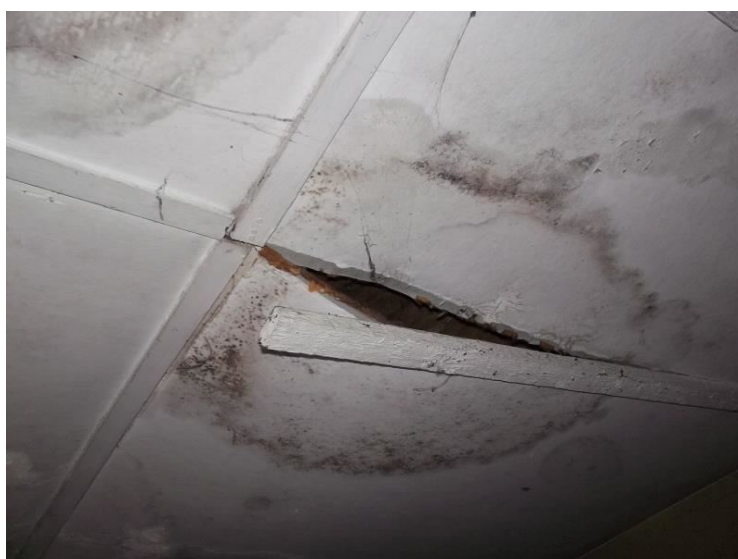
<b>Site:</b>	Newbury Depot	<b>Date of Survey:</b>	16th March 2015
<b>Building:</b>		<b>Survey Conducted By:</b>	William Doward (Lead)
<b>Floor:</b>	Workshop and Mess Room		
<b>Room Ref:</b>	0/002 Locker Room		
<b>Form:</b>	Insulation Products	<b>Sample No:</b>	S275399
<b>Extent:</b>	10 sqm	<b>Lab Analysis Result:</b>	Not Detected
<b>Location:</b>	Paper lining to ceiling panels.

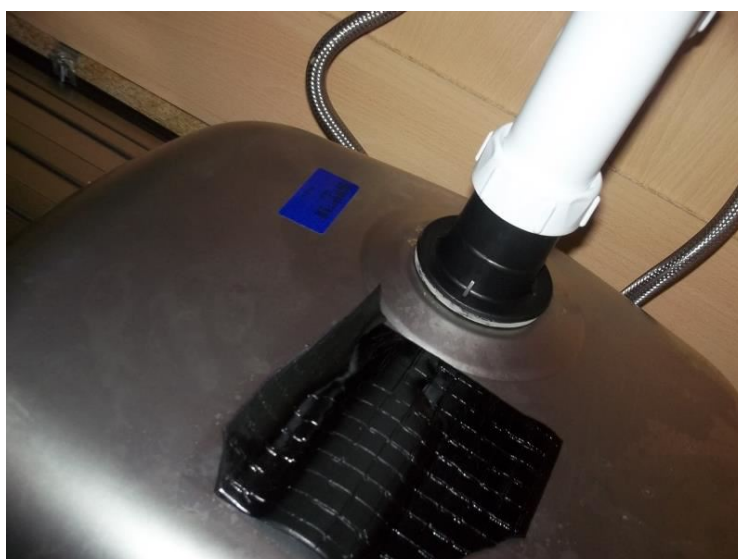
<b>Site:</b>	Newbury Depot	<b>Date of Survey:</b>	16th March 2015
<b>Building:</b>		<b>Survey Conducted By:</b>	William Doward (Lead)
<b>Floor:</b>	Workshop and Mess Room		
<b>Room Ref:</b>	0/003 Kitchen	<b>Sample No:</b>	S275398
<b>Form:</b>	Bonded Materials	<b>Lab Analysis Result:</b>	Not Detected
<b>Extent:</b>	<1 sqm		
<b>Location:</b>	Acoustic pad to sink.

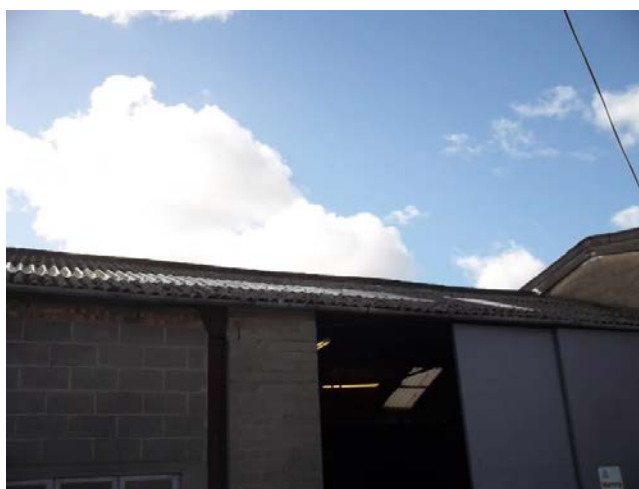
<b>Site:</b>	Newbury Depot	<b>Date of Survey:</b>	15th March 2017
<b>Building:</b>		<b>Survey Conducted By:</b>	Michael Mackenzie (Lead)
<b>Floor:</b>	Workshop and Mess Room		
<b>Room Ref:</b>	Exterior		
<b>Form:</b>	Cement Products	<b>Sample No:</b>	Visual
<b>Extent:</b>	200 sqm	<b>Lab Analysis Result:</b>	Chrysotile
<b>Location:</b>	Corrugated cement forming roof, barge boards and fascias

Material Assessment			
Product Type	Extent of Damage	Surface Treatment	Asbestos Type
1	1	1	1

Total Scores		
Material Risk	Priority Risk	Risk Assessment
4	-	4/D

Recommendations	Action Date
<i>Re-inspect at recommended intervals.</i>	15/03/2018

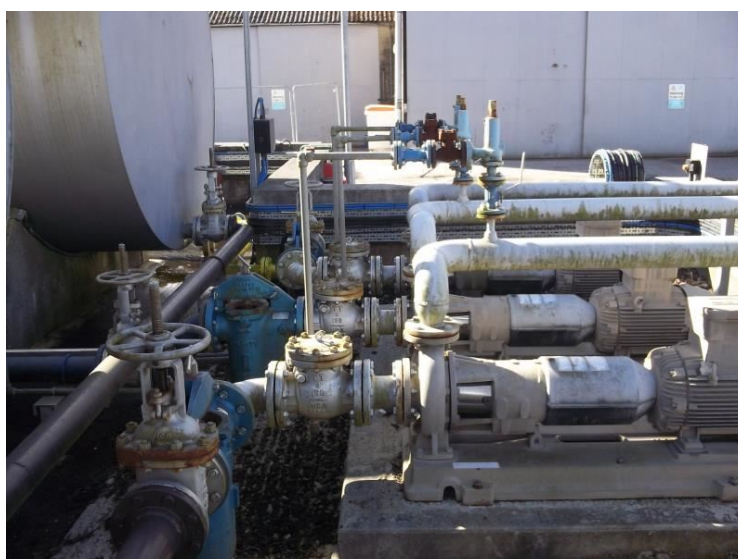
<b>Site:</b>	Newbury Depot	<b>Date of Survey:</b>	16th March 2015
<b>Building:</b>		<b>Survey Conducted By:</b>	William Doward (Lead)
<b>Floor:</b>	Filling Station		
<b>Room Ref:</b>	Exterior		
<b>Form:</b>	Gaskets	<b>Sample No:</b>	S275394
<b>Extent:</b>	>70 No.	<b>Lab Analysis Result:</b>	Not Detected
<b>Location:</b>	Gaskets to pipework flanges throughout filling station area.

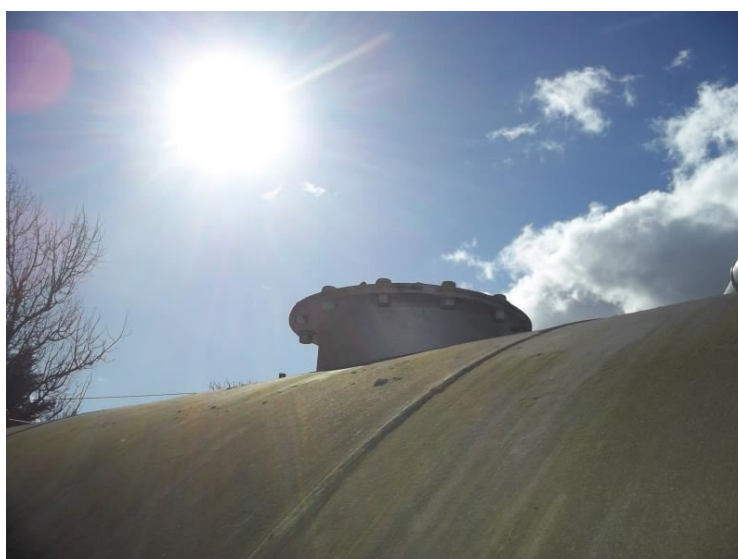
<b>Site:</b>	Newbury Depot	<b>Date of Survey:</b>	15th March 2017
<b>Building:</b>		<b>Survey Conducted By:</b>	Michael Mackenzie (Lead)
<b>Floor:</b>	Oil Storage Tanks		
<b>Room Ref:</b>	Exterior		
<b>Form:</b>	Gaskets	<b>Sample No:</b>	Visual
<b>Extent:</b>	>3 No.	<b>Lab Analysis Result:</b>	Chrysotile
<b>Location:</b>	Gaskets to high level flanges on top of oil tanks.

Material Assessment			
Product Type	Extent of Damage	Surface Treatment	Asbestos Type
2	1	1	1

Total Scores		
Material Risk	Priority Risk	Risk Assessment
5	-	5/C

Room Ref	Asbestos	Sample Ref	Form	Location	Extent	Risk Assessment	Action By
Exterior	Presumed	Visual	Gaskets	Gaskets to high level flanges on top of oil tanks.	>3 No.	5/C	15/03/2018
		<b>Recommendations:</b> Re-inspect at recommended intervals.					
		<b>Comments:</b> Unable to sample due to height restrictions.

Recommendations	Action Date
<i>Re-inspect at recommended intervals.</i>	15/03/2018

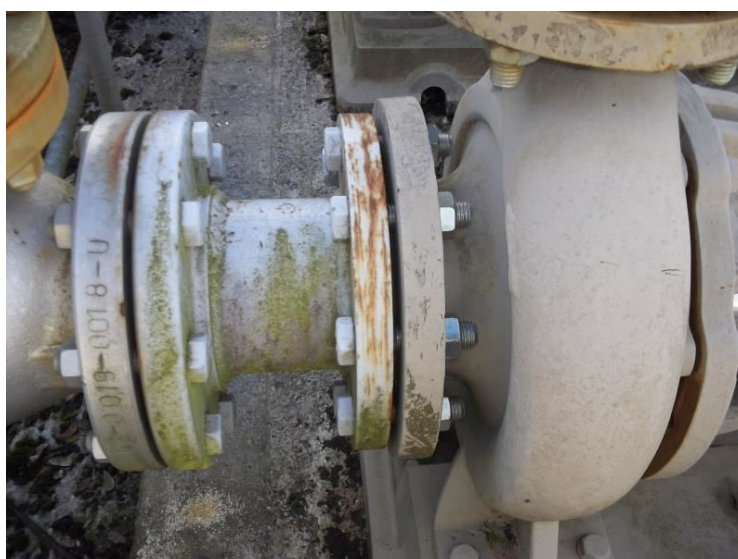
<b>Site:</b>	Newbury Depot	<b>Date of Survey:</b>	16th March 2015
<b>Building:</b>		<b>Survey Conducted By:</b>	William Doward (Lead)
<b>Floor:</b>	Oil Storage Tanks		
<b>Room Ref:</b>	Exterior		
<b>Form:</b>	Gaskets	<b>Sample No:</b>	S275395
<b>Extent:</b>	1 No.	<b>Lab Analysis Result:</b>	Not Detected
<b>Location:</b>	Dark gasket to oil tank pipework flange
