Geotechnical Investigation and Contamination Assessment Report

Park Farm, Gillingham, Dorset

C.G. Fry & Son Ltd

SR/SB/DT/09157/GICAR

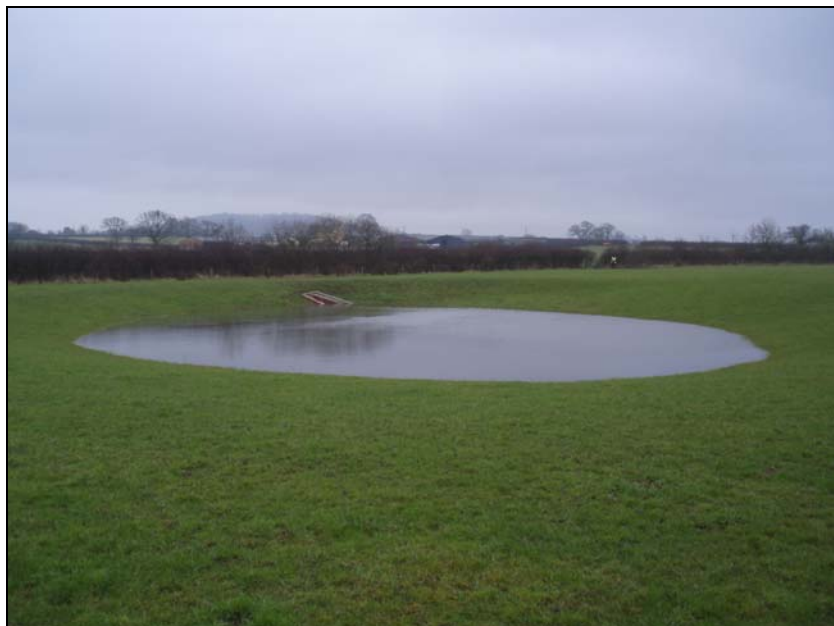
**PLATE 4**

The central-eastern area of the site, showing the presence of an attenuation pond.

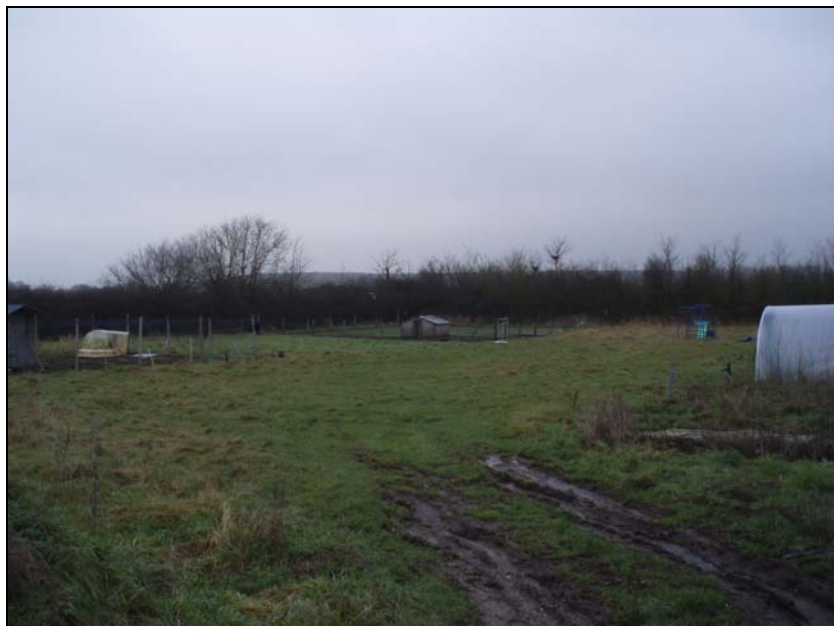
**PLATE 6**

The western area of the site, showing the presence of allotments, hutches and pens.
