NEWHOUSE FARM AND HAM FARM

GEOTECHNICAL INVESTIGATION AND
CONTAMINATION ASSESSMENT REPORT

DECEMBER 2017

TB/SR/14114/GICAR/WL

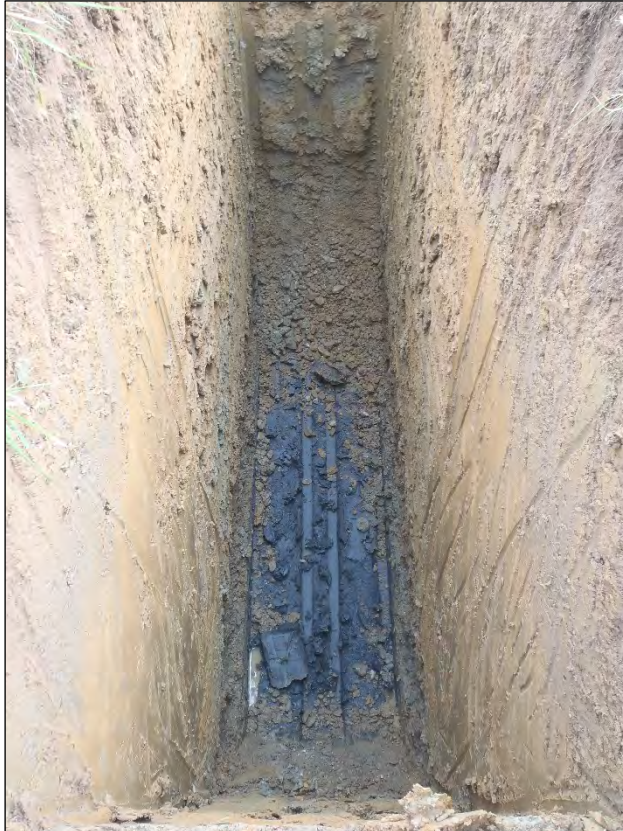
**Plate 8**

Ground conditions encountered in TP49, typical of the ground conditions encountered across the site.

Ground Conditions Encountered	Fifty-three trial pits typically encountered ground conditions of topsoil, underlain by firm to stiff silty clay, with occasional softer horizons and beds of (loose to medium dense) clayey sandy gravel. Groundwater was encountered in approximately 20% of the trial pits.
Foundations	<p>The results of this investigation indicate that strip or trench-fill foundations are generally suitable to support the proposed structures.</p> <p>However, it is noted that the bearing capacity of the soils varies across the site. Similarly, the volume change potential of the soil varies across the site: although much of the site is underlain by clays of medium volume change potential, locally, soils of high and low volume change potential are also present.</p> <p>Prior to development, further, more intensive, investigation is recommended to confirm the bearing capacity and volume change potential of the soils in a particular area.</p>
