Geotechnical Investigation and Contamination Assessment Report

Park Farm, Gillingham, Dorset

C.G. Fry & Son Ltd

SR/SB/DT/09157/GICAR

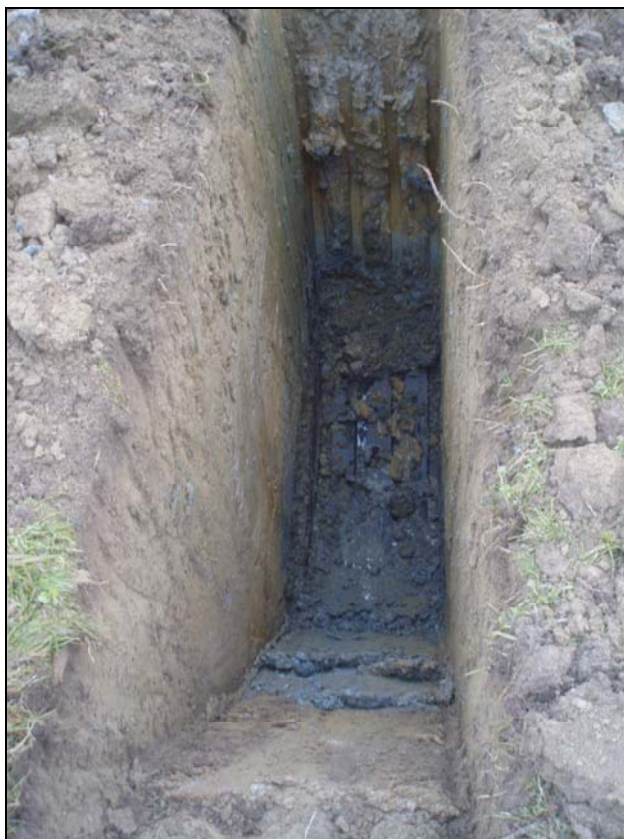
**PLATE 8**

Ground conditions encountered in TP6, typical of ground conditions encountered across the site.
